# PHYSICAL PENETRATION TEST

*Case Study*

## 2 PHYSICAL PENETRATION TEST AT A TIER-1 EUROPEAN INSURANCE COMPANY

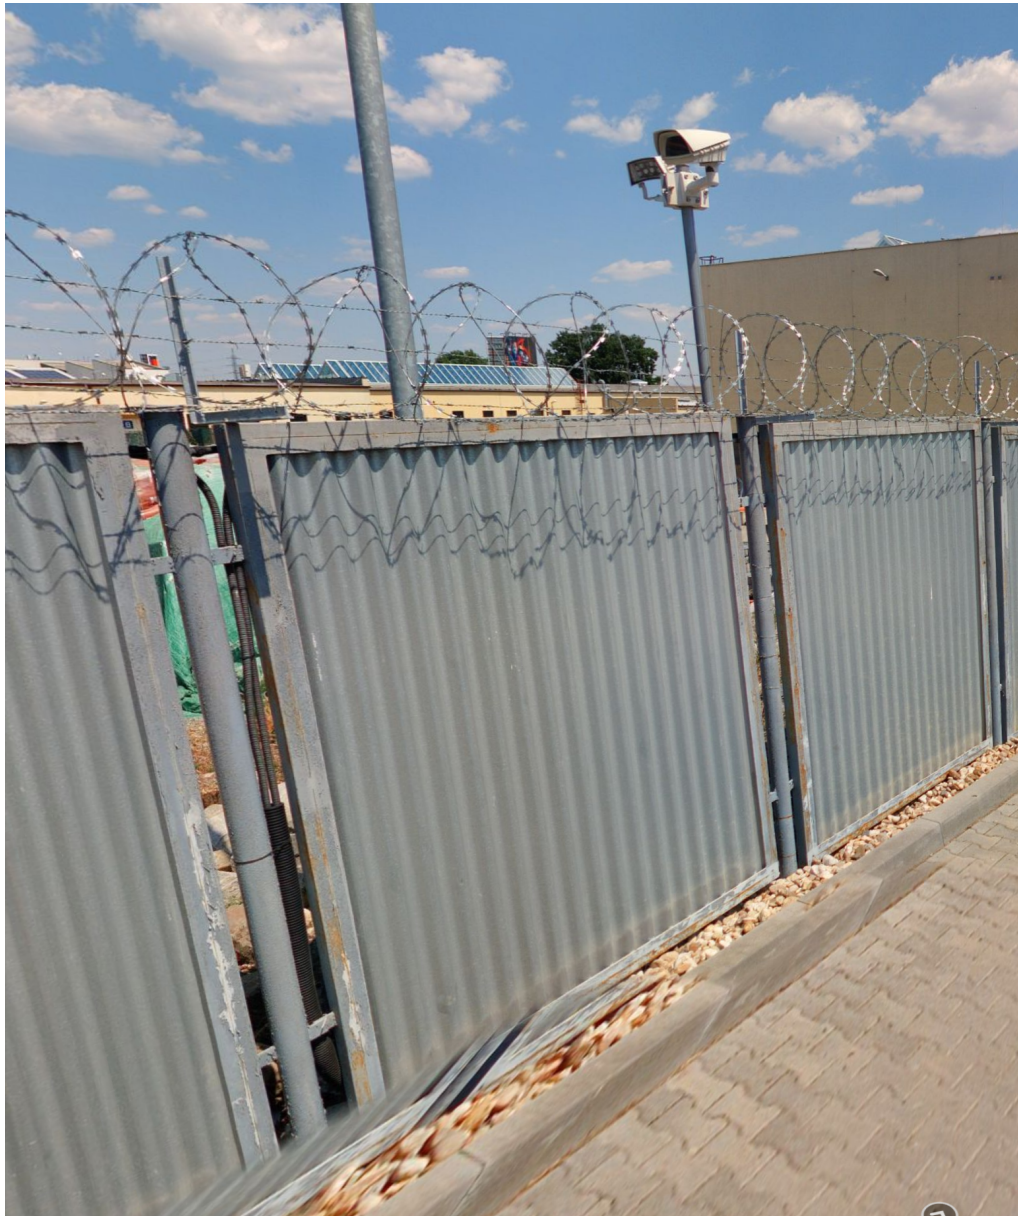
- Exact **camera placements, angles, and blind spots** outside the headquarters.
- **Building entrances** and likely locations of elevators and stairwells.
- Information on the **public café and canteen** within the building, including opening hours.
- Layout of the **lobby and reception area**.
- **Access badge design** obtained from social media.
- Several photos showing employee workplaces.

*Fig. 1 – a camera with infrared light.*

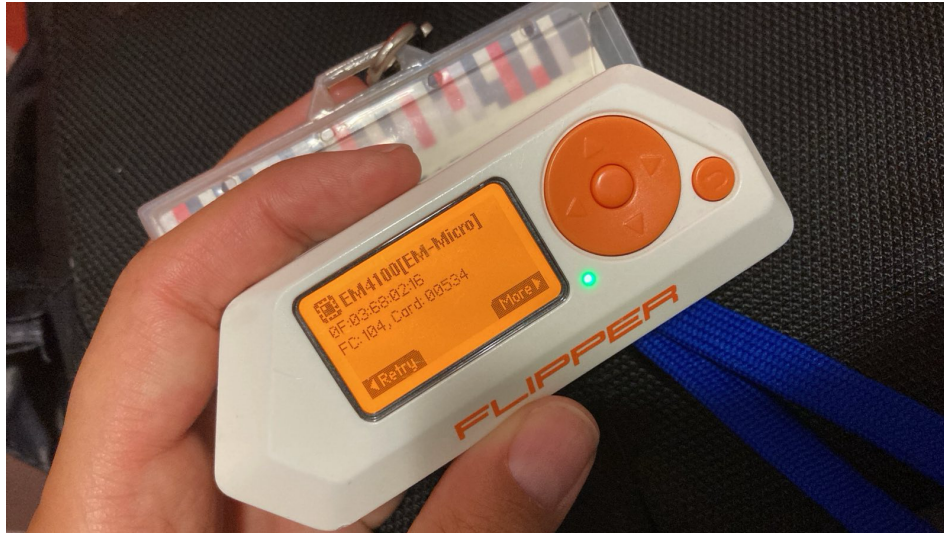
- Tested reception:
  - Receptionists asked for ID but accepted excuses, issuing visitor badges after only a surname check.
  - Visitor badges could be cloned due to insecure card technology.

*Fig. 2 – clone of a visitor's badge.*

1. **Upgrade physical access control system (PACS)** to a secure standard resistant to cloning.
2. **Comprehensive training** for guards, receptionists, and staff to identify and handle suspicious behaviour.
3. Replace locks in executive and sensitive areas with **high-security cylinders**.
4. Implement **intrusion detection/alarm systems** in executive offices, boardrooms, and data-sensitive zones.
5. Establish a **regular red-team/penetration testing cycle** to validate improvements.

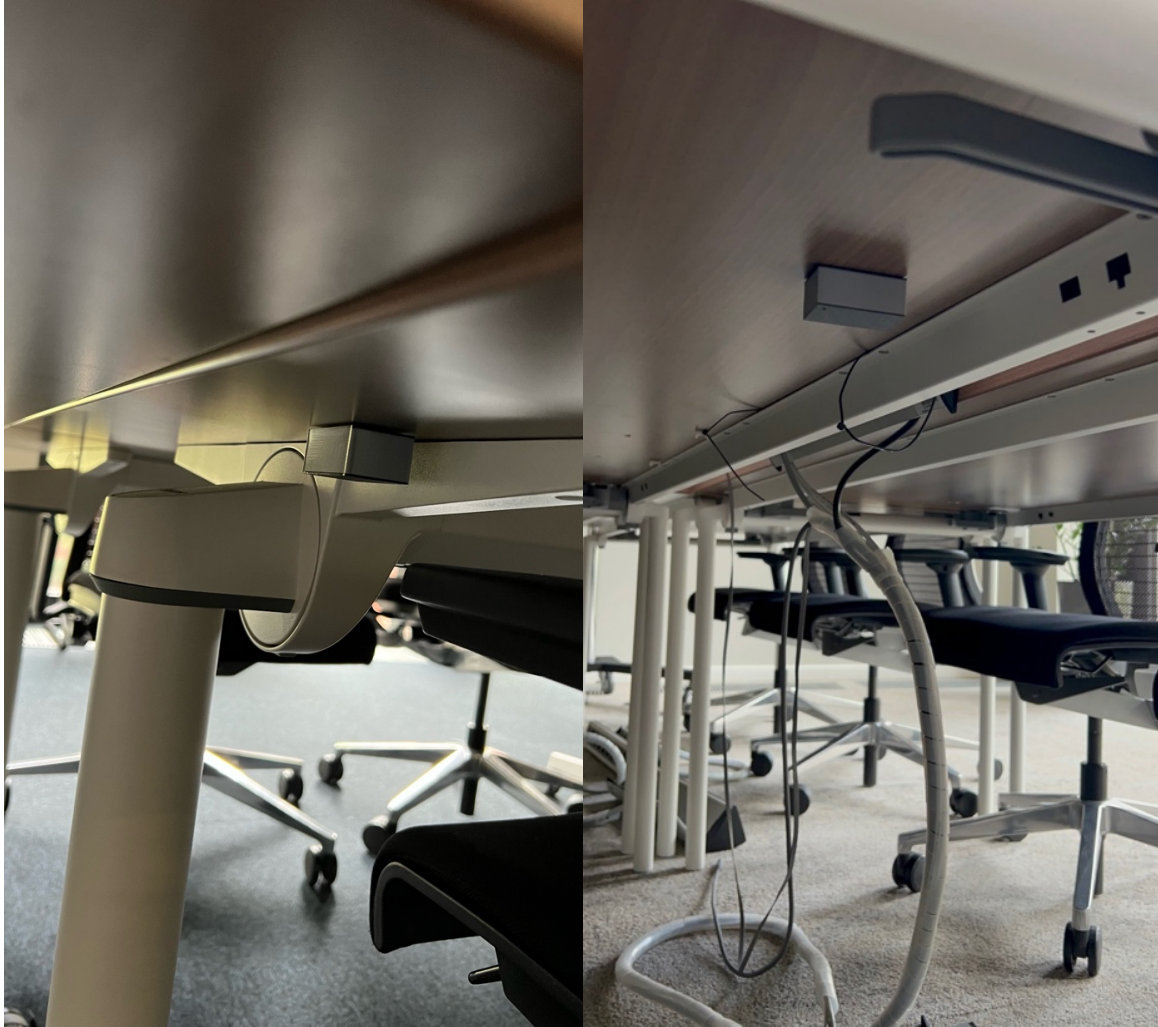
- Accessed multiple office floors.
- Placed **surveillance simulators** (dummy listening devices) in meeting rooms, phone booths, and workplaces.
- Prepared for the main objective – gaining access to the **executive floor**.

*Fig. 3 – placed surveillance simulators (grey boxes) in multiple meeting rooms.*

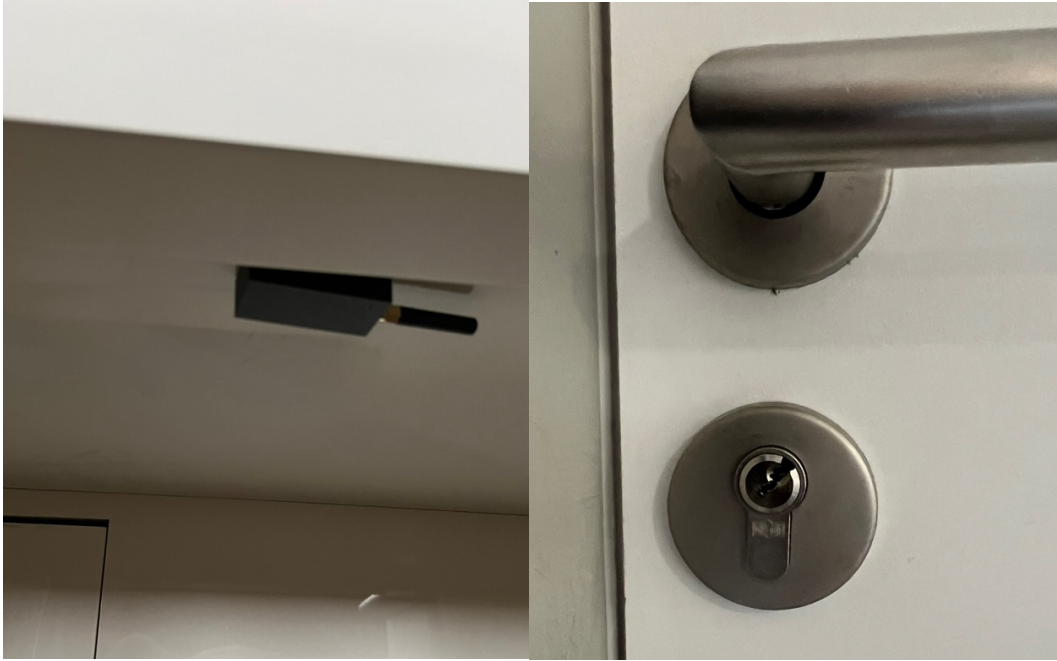
- **COO's office:** locked; picked open in ~60 seconds. Photos were taken, and a symbolic team flag (company mascot) was placed.
- **CEO's office:** accessed even faster via lock-picking; again, photos and flag placement.
- **Boardroom:** older, worn lock – picked in under two minutes. Surveillance simulator placed and documented.

*Fig. 4 – placed surveillance simulator in the Board room and picked open the lock on the CEOs office.*
